Appendix A9.1

Noise & Vibration Survey

Appendix A9.1: Baseline Noise and Vibration Survey

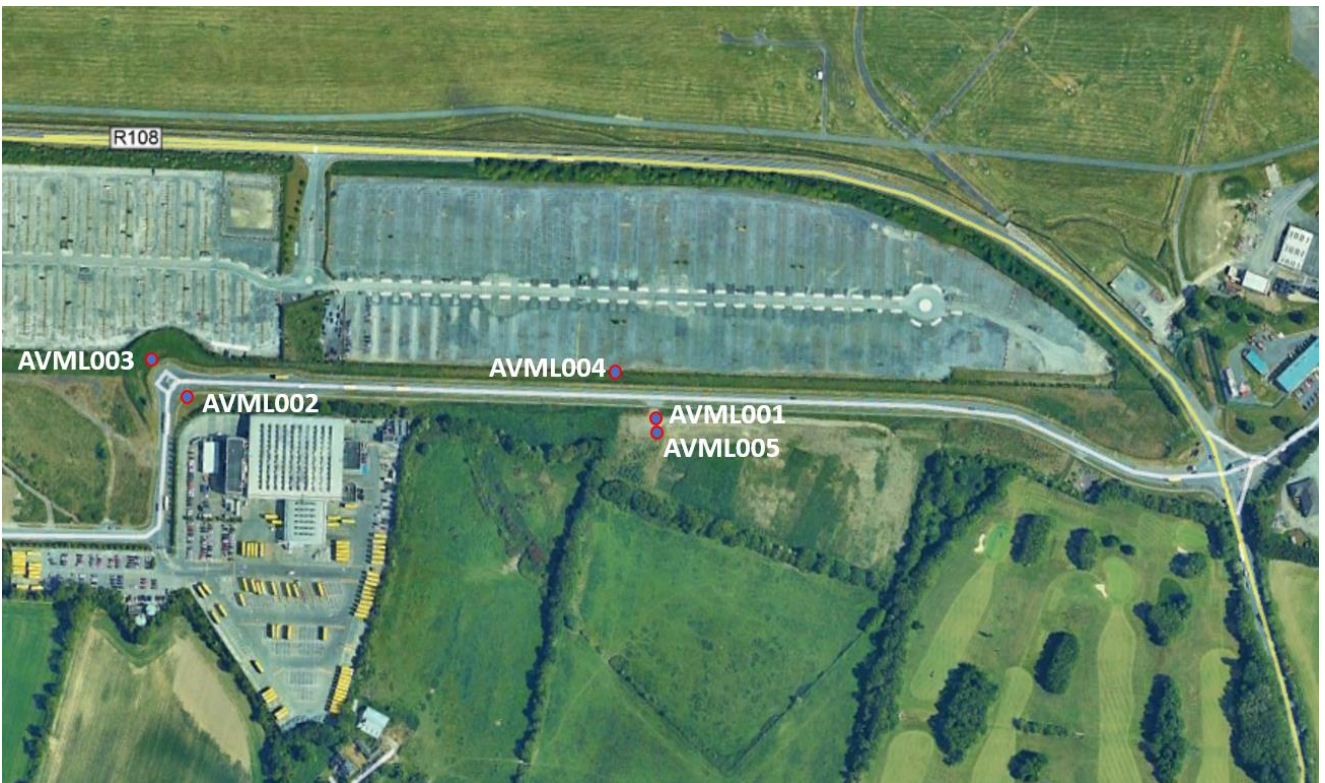
Figure 1: Vibration Monitoring Locations Harristown Bus Depot (source Google Earth)

The survey locations undertaken along the Harristown Bus Depot entrance are illustrated in Figure 1. The survey locations undertaken along the Malahide Road are illustrated in Figure 2.

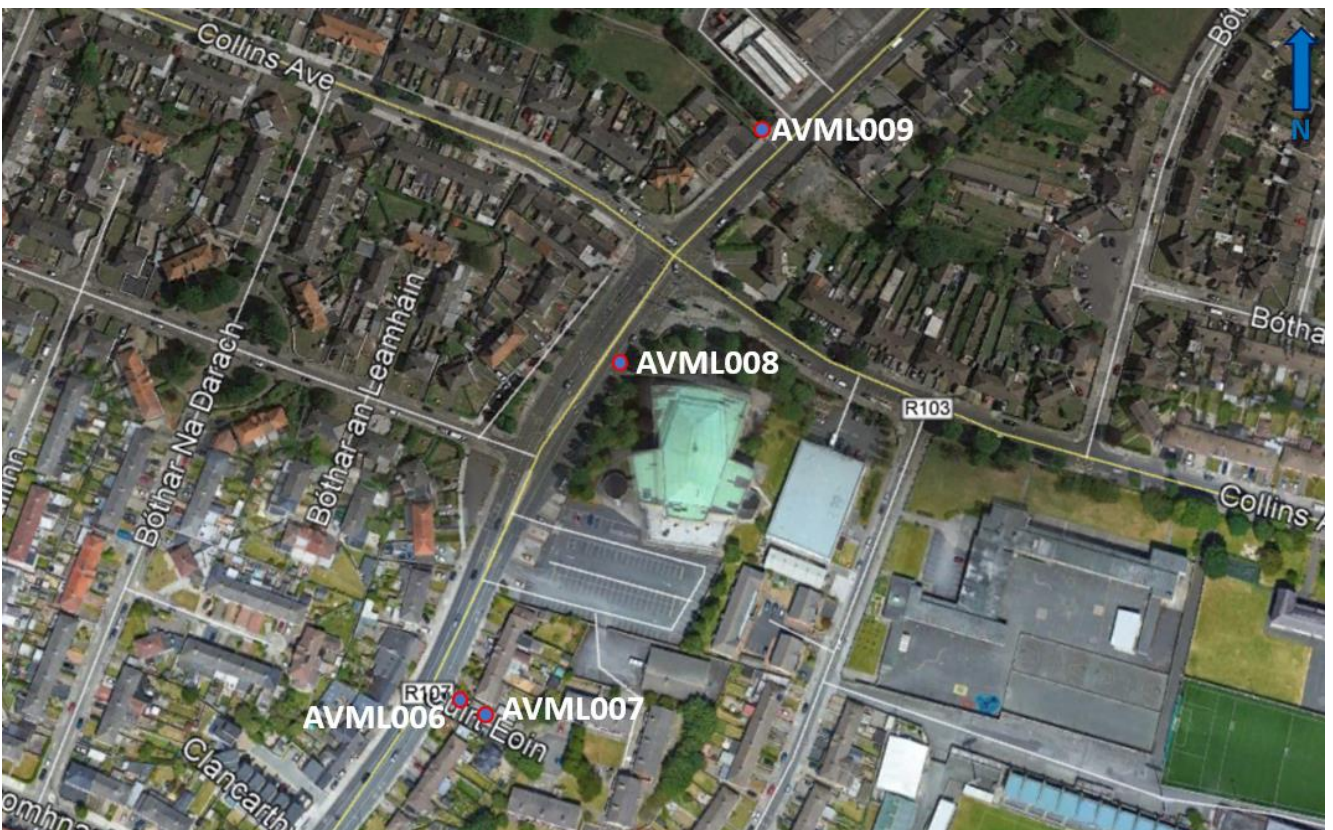
Figure 2: Vibration Monitoring Locations Malahide Road (source Google Earth)

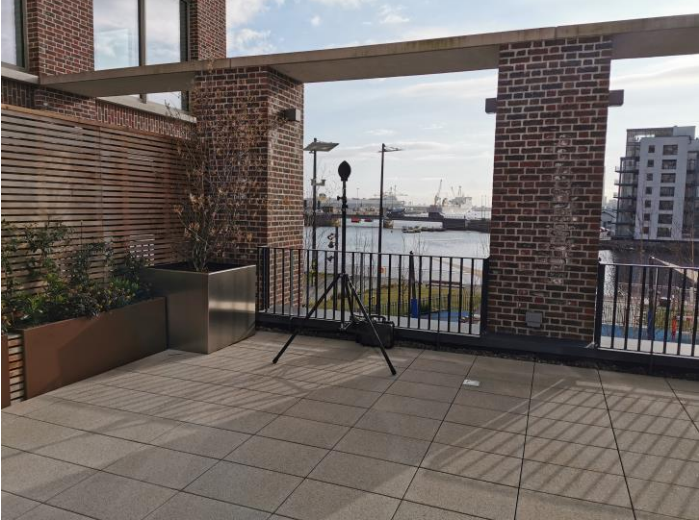
Location	Equipment Set up
<p>CBC0016UNML001</p> <p>In external roof garden on first floor of residential NSL in Capital Dock, Britain Quay facing east towards River Dodder.</p>

A photograph showing monitoring equipment set up on an external roof garden. The equipment, including a sensor on a tripod and a weather station, is positioned on a paved area. The garden is enclosed by a brick wall and a metal railing. In the background, a river (River Dodder) and a cityscape are visible under a clear sky.

For unattended surveys, a Rion WS-15 Outdoor Microphone Protection System with microphone extension cable and outdoor peli-case was used. An image of the equipment install at the one unattended monitoring location is included in Section 4.

For the unattended noise survey, the monitoring equipment was installed in an external roof garden of the first floor of an apartment development. The microphone was installed at a height of approximately 1.5m above ground. The equipment was set to log for 15 minute intervals on a continual basis over a ten day period.
